**Flood Control Project Maintenance
Levee Inspections**
LMA District Cover Sheet
Spring 2018 Levee Inspection Results

Reclamation District No. 0554 Walnut Grove

Spring 2018 Levee Inspection Results

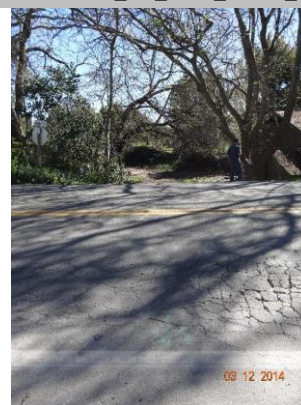
Photo 2 of 3 : UCIP_SP_2018_32021_58474.jpg

LM Start	0.89	Rating **	M	Issue No.	48 (cont)
LM End	0.89	Issue Type +	En	Location *

View of levee crown.

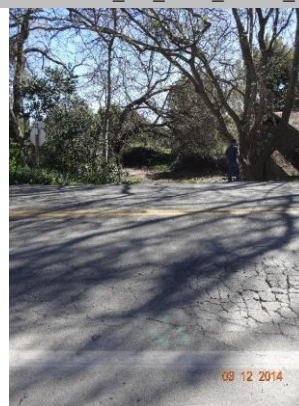
Photo 2 of 3 : UCIP_SP_2018_32022_58479.jpg

LM Start	0.89	Rating **	M	Issue No.	49 (cont)	
LM End	0.89	Issue Type +	En	Location *		
Category	Supplemental			GPS Latitude/Longitude		
				Start		End
Item	DWR UCIP Field Study			38.238595 °		38.238595 °
				-121.516945 °		-121.516945 °
DWR ID						
Comment Code						
Inspector Comment						
FS_ID:32022 DS_ID:20942 EP_NO: N/A Repair Type: Non-Urgent Crossing Status: Indicator Found UCIP Comments: Unable to confirm how many sewer lines cross levee. Desk study shows 2 crossings 4-inch not 6 inch. Need to contact owner to confirm status of crossing. FIELD_STRUCT_DESC: 2 of 2: 4-inch clay sewer pipe through the levee, 10.2 feet below the crown. (USACE-1959). This entry matches the Drainage or Irrigation Structure referenced in O&M manual (RM 26.50). FS Date: 3/12/2014

View of levee crown.
